Historic Structures Report

OLD LAHAINA COURTHOUSE

December 16, 1996

**Spencer Mason Architects
1050 Smith Street
Honolulu, Hawaii 96817
(808) 536-3636**

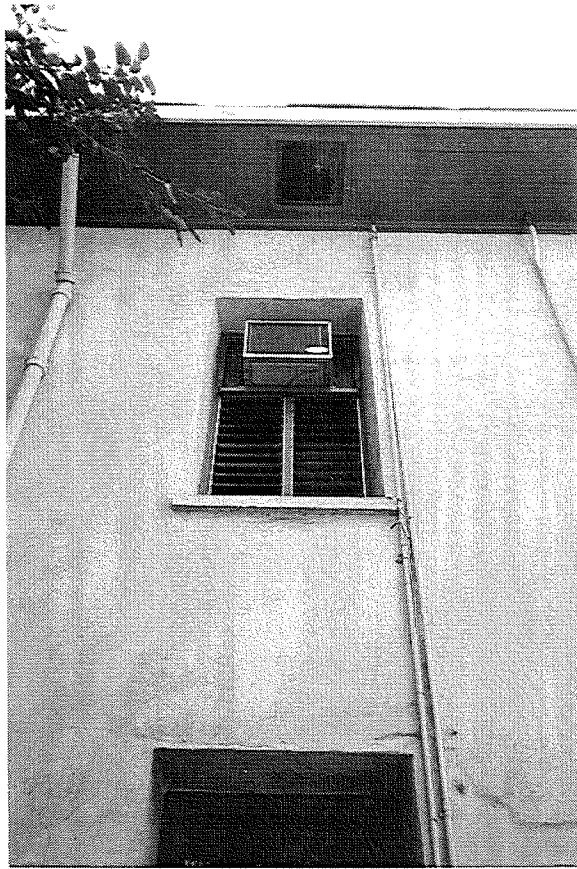
Figure 10. Broken eave screen

The original roofing was a clay mission tile (figure 3). The existing roof covering is asphalt shingles. The asphalt shingle roofing appears to be in fair condition. The existing sheathing, truss system and ceiling framing appear to be in very good condition. Structural analysis and recommendations are detailed in Appendix "A". All the eave vents have broken screens which have allowed birds to enter the attic (figure 10).

- 1. The mission tile roofing should be reinstalled, using a good quality clay tile matching the profile that can be seen in the historic photographs. This type of roofing is durable and although it needs regular maintenance is not a high-maintenance roof. It should be installed with stainless steel nails and stainless steel hold downs.*
- 2. The roof structure should be tied to the exterior walls at the wall plate. (See structural report, Appendix "A")*
- 3. All screens at the attic vents should be replaced with stainless steel mesh.*

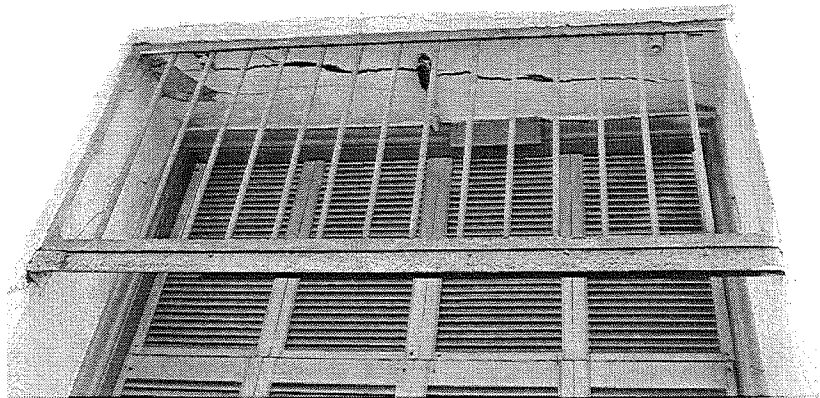
Figure 11. Crack at window lintel

Examination of the exterior walls revealed many cracks in the exterior plaster and large areas of wall where the plaster is not bonded to the masonry substrate. Generally the south and west elevations are in poorer condition and the majority of the problems occur in the first story height of the walls. Vertical cracks were often found adjacent to the sides of window and door openings with an area of hollow-sounding plaster extending beyond the crack away from the opening. Spalling and cracks were also noted in some lintels and sills (figure 11). Any cracks in horizontal surfaces can allow rain water to penetrate into the wall.

Without removing the plaster it is not possible to tell whether these cracks are only in the plaster or if they extend into the wall substrate and are due to structural movement, but we expect it is the former. The cracking and bond failures of the plaster seems to be due to the action of three decay processes. First, cement plaster is hard and brittle. Any wall movement, such as shrinkage, thermal expansion/contraction or settlement is likely to result in cracks in the cement plaster. This is especially true when there are no contraction joints built into the plaster surface to relieve those stresses.

- 1. All areas of cracked and hollow-sounding exterior plaster should be removed and repaired with cement plaster.*
- 2. When the plaster is removed the walls should be inspected to see if any significant structural cracks exist.*
- 3. Where rusting metal elements built into the wall are causing spalling the metal should be removed if possible. If it must remain (e.g. reinforcing bars) the rust should be removed and the metal item coated with rust inhibitive primers.*

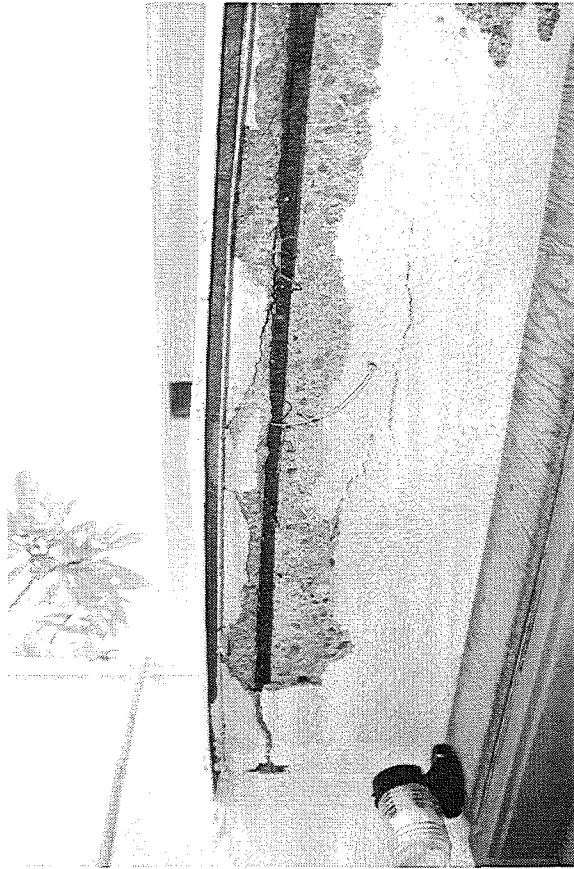
Figure 12. Crack at basement door lintel

The third cause of exterior plaster failure is from the expansion of rusting metal elements built into the wall (figure 12).

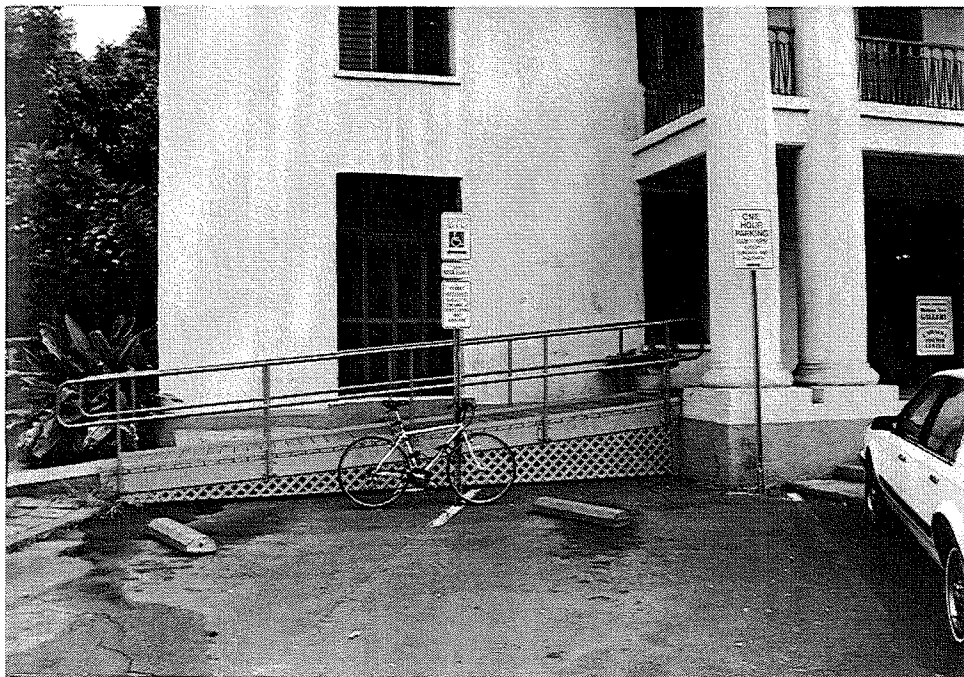
Figure 13. Existing ramp

There is a wood ramp leading up to the north end of the makai landing (figure 14). The ramp appears to be in reasonable condition but does not meet all the requirements for disabled access. In addition, it hides the historic steps on that side that used to serve as exterior access to the post office.

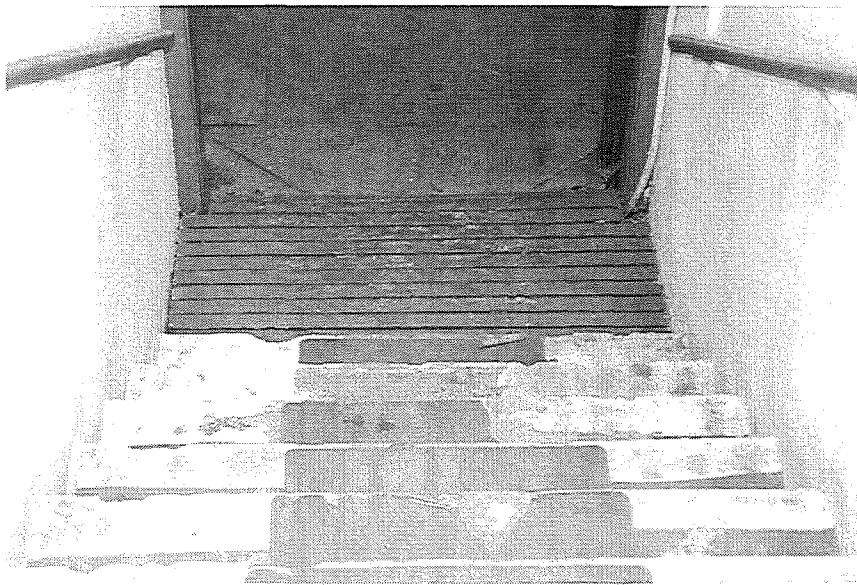
Figure 14. North stair to basement

The stairs to the basement are in the middle of the north and south elevations. Currently the north (Kaanapali) stair is used for public access to the art gallery in the basement, the south stair seems to be used only for service access. Both stairs have chipped and spalling steps, at the north stair almost every nosing is chipped (figure 14). The stairs are not protected from the weather and a sump at the bottom landing collects rainwater which is then pumped up to drain at the ground level. On the north stair a slatted wood floor covers the bottom landing and raises the level to the top of the door threshold. Both stairs have a change in level of about 2-1/2 inches at the top landing where the top treads meets the higher concrete walkways that run parallel to the north and south elevations. This is a dangerous condition and is also a code violation.

1) Provide new metal (painted stainless steel) handrails for both basement stairs. These shall be simple round rails.

2) Repair chipped and spalling nosings with epoxy modified cement mortar.

3) Replace the sump pumps. Connect the pumps to an overflow head in the landscaping to return any water to grade level.

4) Correct the 2-1/2" step condition by moving the walkways at least 4 feet further away from the building and ramping to accommodate the difference in level. Install a trench drain at the connection between the existing stair and the new walkway. The raised walkways serve a useful function in preventing sheet flow of rainwater in a heavy storm from flowing down into the basement stair ways. It is therefore preferable to keep them at their present height.

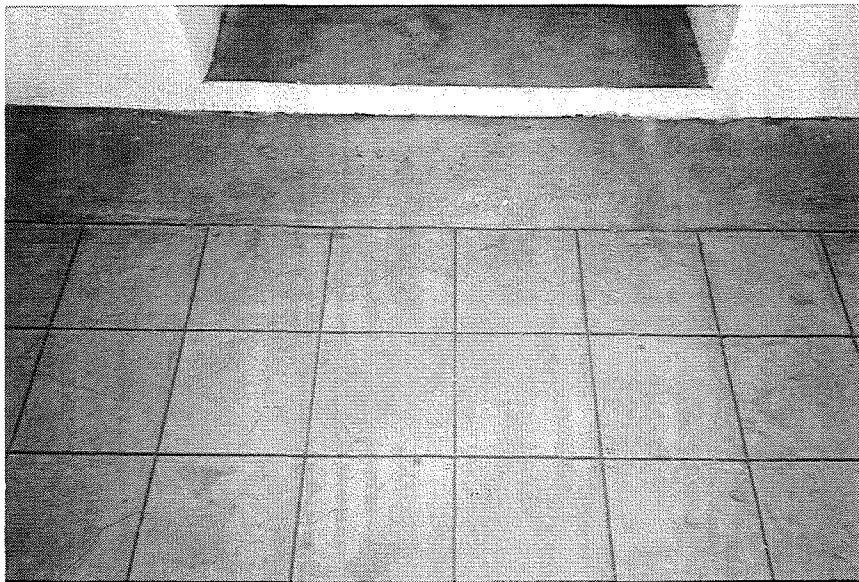
Figure 15. Balcony floor

Some cracking of the plaster on the columns was noted. The front edge of the balcony floor is spalling badly in two places. The balcony railing is rusting all over, but is in relatively good condition. The second floor balcony rail is 33" high, which is 9" lower than code allows. The first floor lanai has no guard rails despite the floor being 31-1/2" above the surrounding grade.

1. *Repair the spalling concrete at the front edge of the balcony with epoxy modified cement plaster.*
2. *Remove rust from the second floor railing by sand blasting. Prime steel with epoxy primers and repaint to historic colors. Make no other changes to that railing.*
3. *Thoroughly clean and seal concrete floors.*
4. *Install a single rail at 36" above the lanai floor at each end. Regrade soil against ends of the lanai to decrease the height to grade to less than 30".*

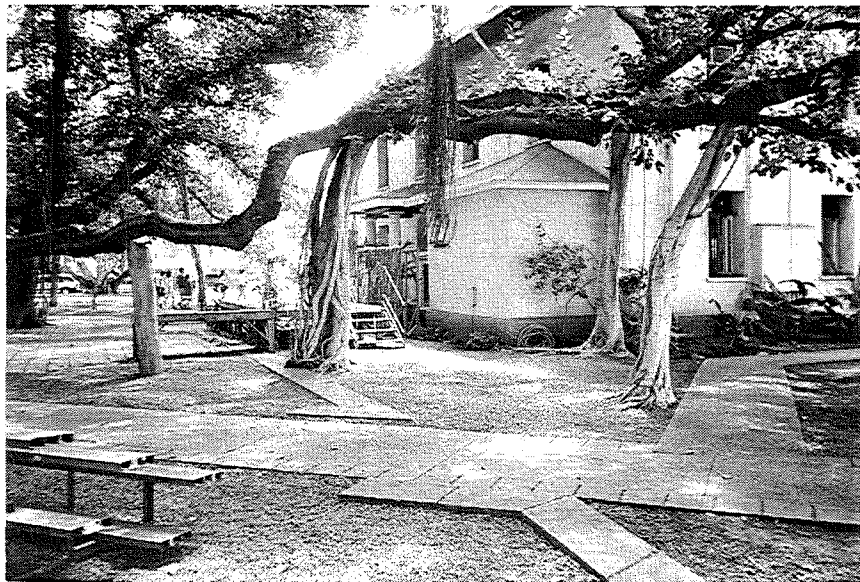
Figure 17. One story addition

The single-story plastered masonry addition at this location is compatible in appearance with the rest of the two-story building (figure 17). Connection to the addition was made by cutting through the original wall (figure 18). In addition, there is a wood and mesh enclosure for an air conditioning condenser that serves the basement. These elements should ideally be removed to restore the exterior of the building to its 1925 appearance. However, some location must be found for mechanical and electrical equipment to serve the building, as mechanical ventilation and/or air conditioning is required for the basement and electrical service panels will be required somewhere.

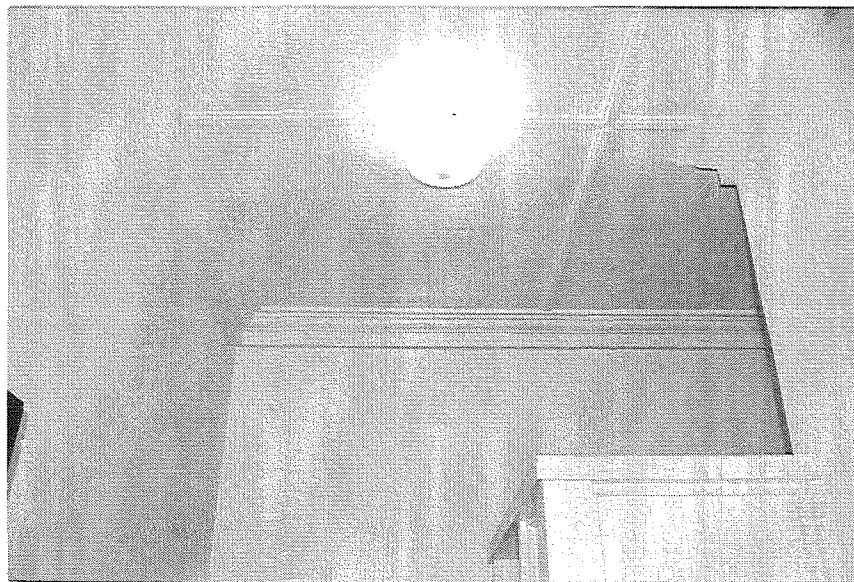
Figure 21. Ceiling in toilet room

Existing ceilings are gypsum board and many are subdivided into rectangular panels by wood moldings (figure 21). Most of the rooms on the first and second floor have wood cornice moldings. The ceilings are generally in good condition.

1. *Although the ceilings are in good condition, it is recommended that they all be removed. Existing cornice and panel moldings shall all be salvaged and reused. New gypsum board ceilings and the existing wood moldings shall be reinstalled. This work is proposed for two reasons: the first is a need to use the floors for seismic strengthening of the building. (Appendix A). To create a diaphragm at the floor level it is necessary to add plywood to the floor. Adding plywood above the floor creates step problems at thresholds and stairs, so installing it under the floor structure is better. The second reason is that opening up the floor surface allows more opportunities for hiding new electrical, telephone and data lines throughout the building.*

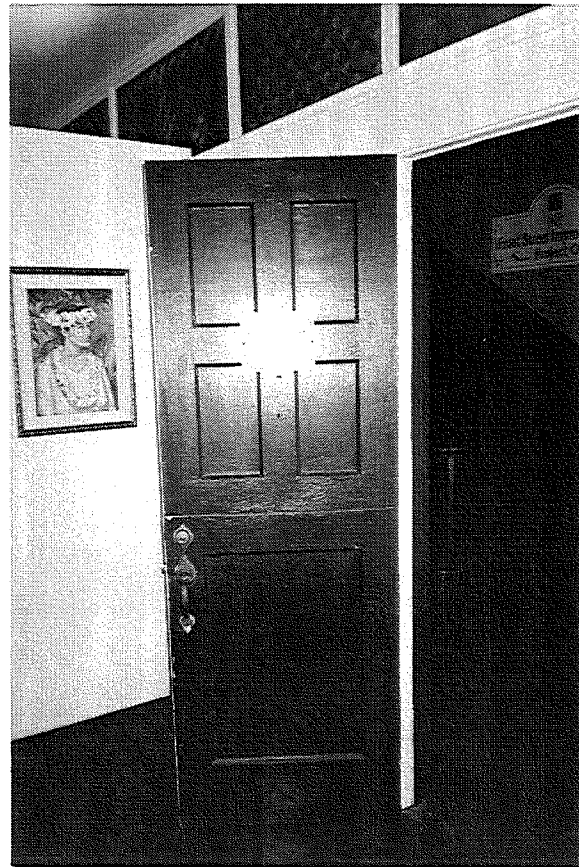
Figure 23. Double dutch door at existing opening D26

Parts of the door originally located at opening D17 is the door labeled D26. Door 26 is a double Dutch door with hardware that matches the original hardware in the building (figure 23). The HABS drawings indicate the door at D17 had upper doors with glass lights, while the existing upper doors are solid four-panel doors. It is theorized that the lower parts of the dutch doors are original and the glass lights were replaced with the solid panel doors when the doors were shortened to fit in the interior.

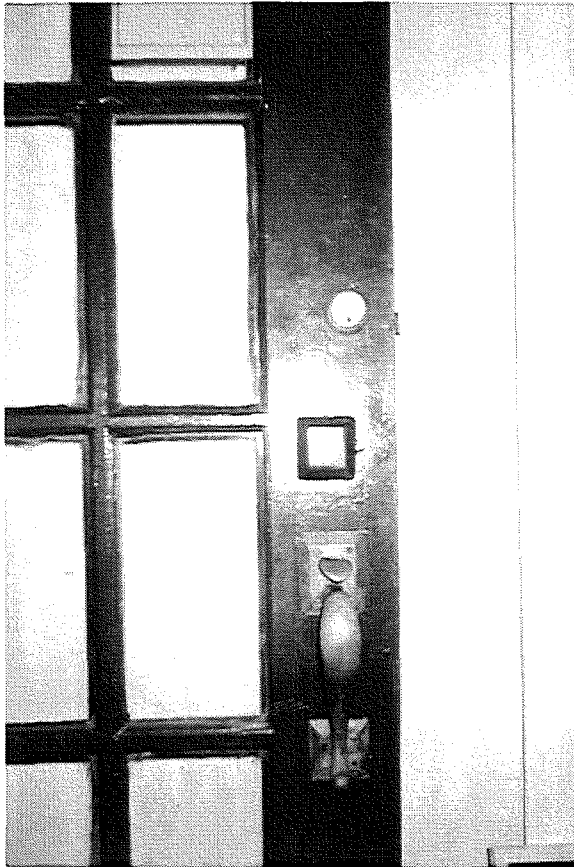
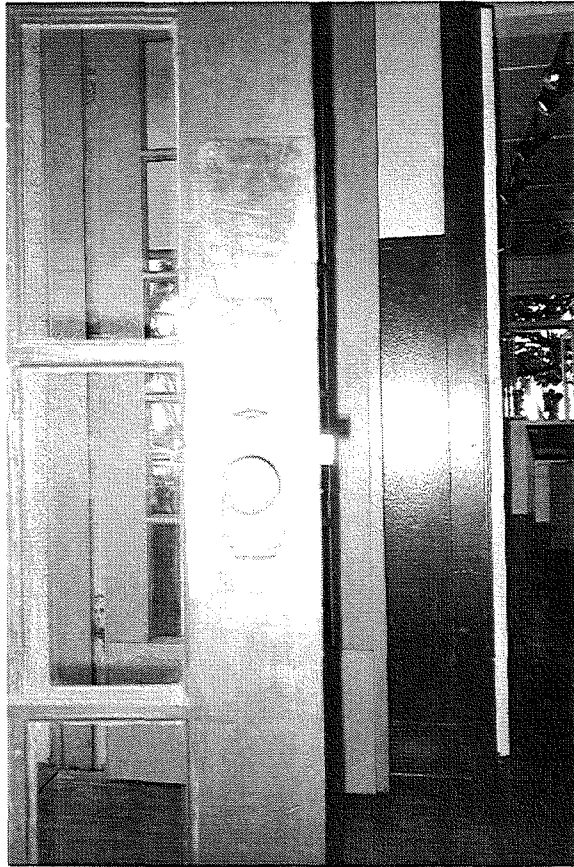
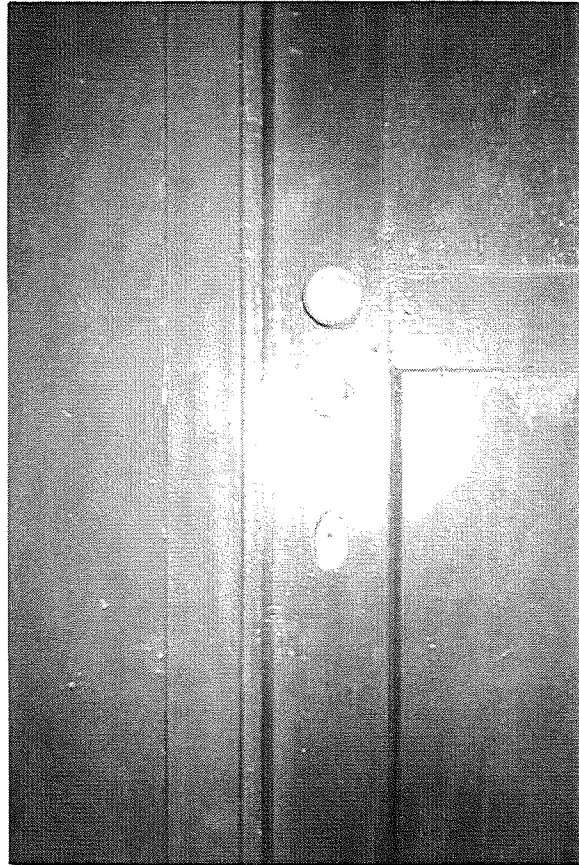
Much of the original hardware remains (figures 24, 25 & 26). The locksets and latchsets are typically bronze and can be refurbished to be operable. The hinges are all ball-tipped steel hinges and most are rusting.

1. *The repairs listed in the door schedule should be performed.*
2. *Hinges shall be replaced with bronze hinges of identical configuration to the originals. Other door hardware, including original door locksets, shall be retained.*

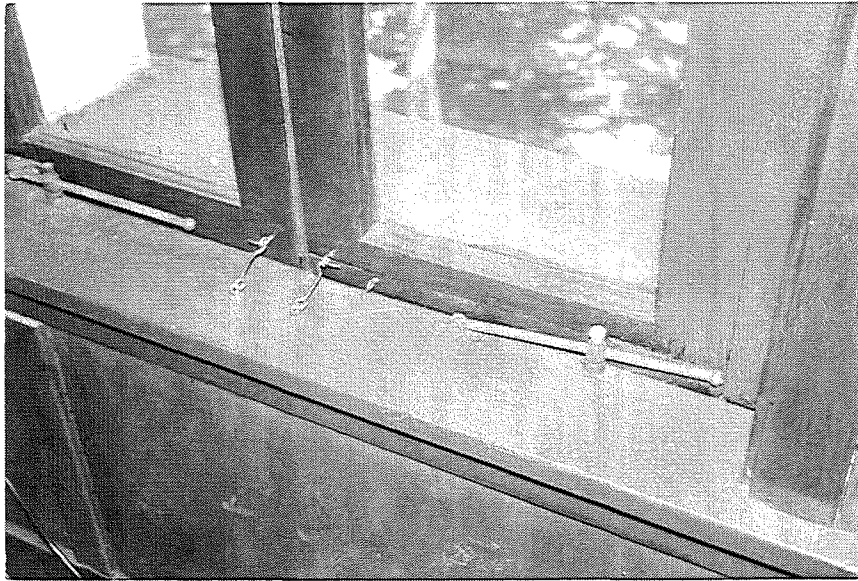
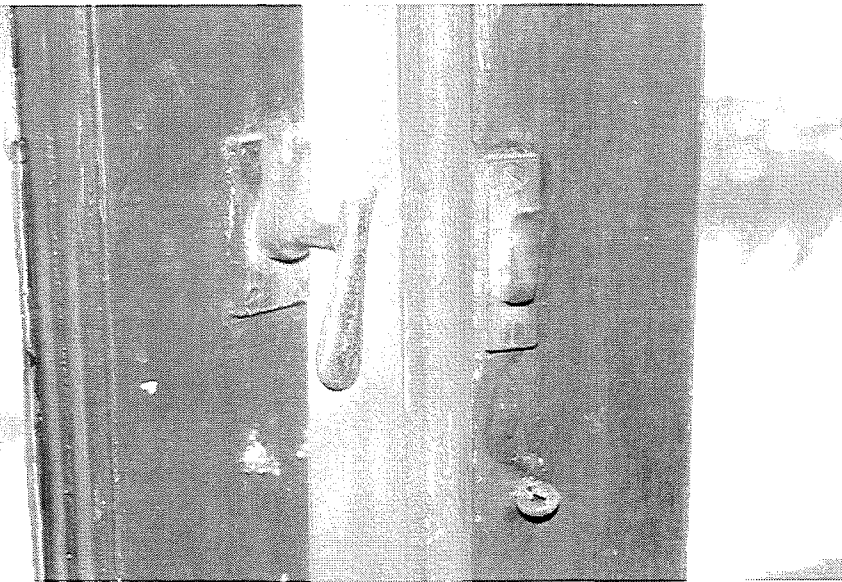
The 1925 restoration drawings indicate the windows are to have "Whitco" sashes. This refers to the sliding hinge and stay system (figures 27, 28). In several windows these sliding hinges are missing and have been replaced with regular hinges, this change has required the exterior molded casing to be cut to allow the sash to swing. Many of the windows have missing, broken and/or miss-matched hardware, hardware repairs are listed in the window schedule.

- 1. The exterior shutters should be removed from window 22.*
- 2. All jalousie windows and all plywood panels and framing for a/c units should be removed*
- 3. The repairs listed in the window schedule should be performed. Replacement sashes are required in windows nos. 3, 9, 10, 11, 12, 13 & 22. The loose casements found on site can be used for one of these windows. Replacement transom sashes are required in six windows, four of these can come from the sashes found on site.*
- 4. The security grilles in the transoms of windows nos. 23, 24 & 25 should be removed.*

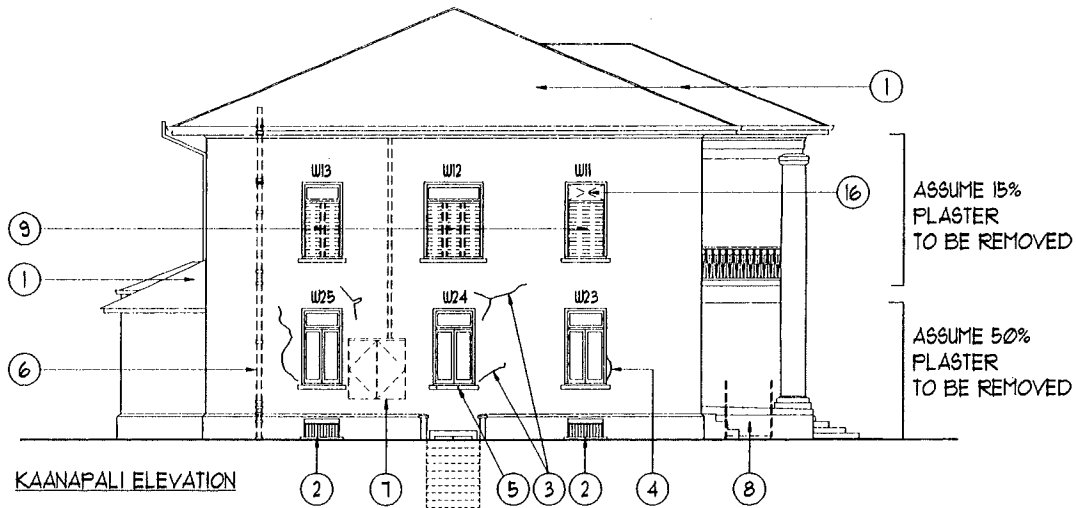
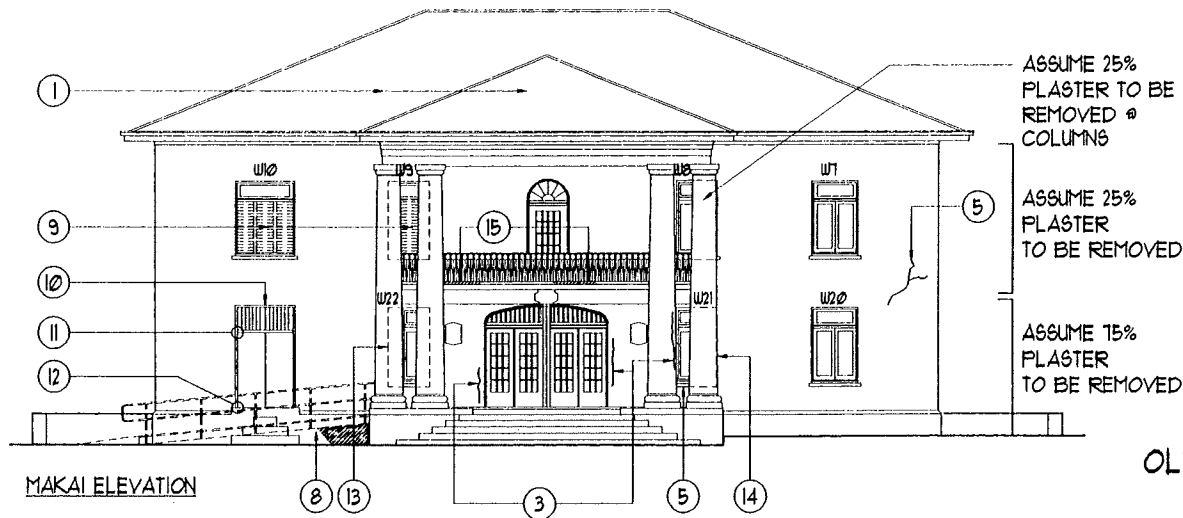
Drawing E5: EXISTING EXTERIOR ELEVATIONS

- ① REMOVE EXST. ASPHALT SHINGLES ROOFING.
- ② REMOVE EXST. WINDOW.
- ③ CRACKS
- ④ MINOR CRACKS
- ⑤ CRACKS IN SILL
- ⑥ REMOVE EXST. VENT PIPE
- ⑦ REMOVE EXST. ELEC. CABINET
- ⑧ DEMOLISH WOOD HANDICAP RAMP.
- ⑨ REMOVE EXST. JALOSIE WINDOW.
- ⑩ SPALLING AND CRACKS @ LINTEL
- ⑪ CRACKS @ FIXING
- ⑫ SPALLING @ NESTED METAL @ SILL
- ⑬ CRACKS @ JAMB AND INGO.
- ⑭ CRACKS @ WINDOW INGO.
- ⑮ EDGE BADLY SPALLING.
- ⑯ REMOVE EXST. AIR CONDITIONER.

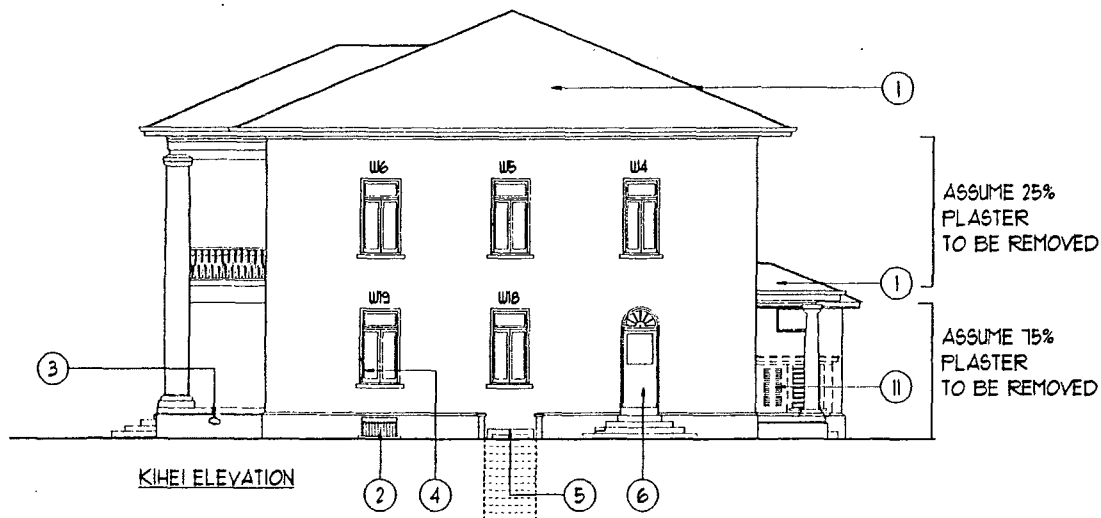
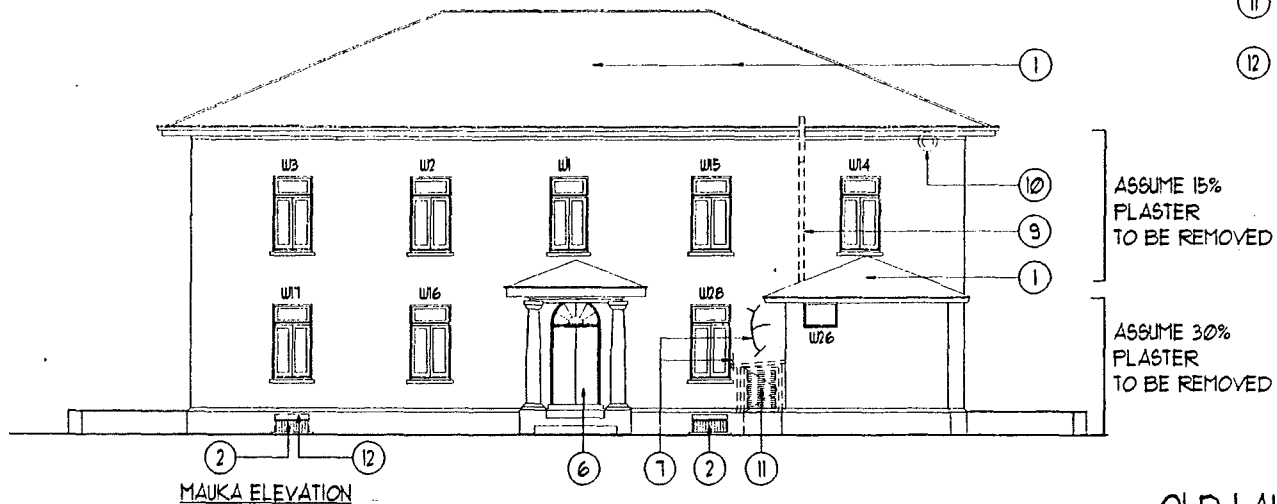
Drawing E6: EXISTING EXTERIOR ELEVATIONS

- ① REMOVE EXST. ASPHALT SHINGLES ROOFING.
- ② REMOVE EXST. WINDOW.
- ③ SPALLING PLASTER
- ④ PLASTER BULGING.
- ⑤ LINTEL BADLY SPALLED.
- ⑥ RETAIN EXST. DOOR
- ⑦ CRACKS.
- ⑧ MINOR CRACKS.
- ⑨ REMOVE VENT PIPE.
- ⑩ REMOVE SIREN.
- ⑪ REMOVE EXST. COMPRESSOR AND DEMOLISH ENCLOSURE.
- ⑫ CRACKS • UNDERSIDE OF LINTEL.
