Proposed Construction of a Retaining Wall  
Walter Hester Residence

TMK (2) 4-3-015: 003  
Napili, Maui

Special Management Area Use Permit  
Shoreline Setback Variance

Maui Planning Commission Meeting  
July 23, 2013

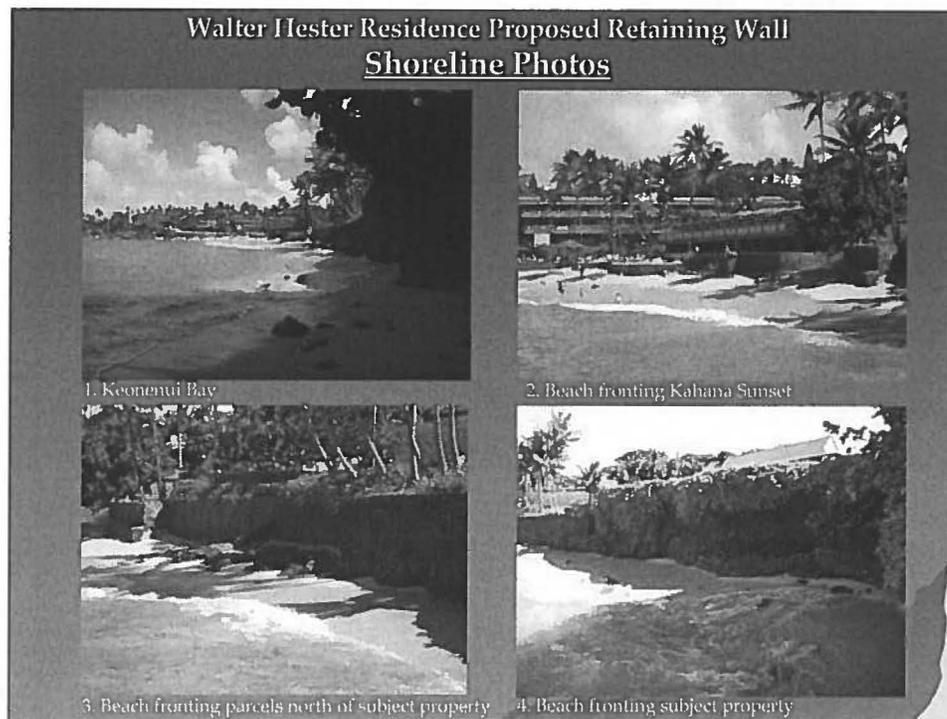
1. The picture in the top left shows the length of Keonenui Bay.

2. North of the subject property, fronting the Kahana Sunset, the shoreline consists of a sandy beach protecting the properties.

3. & 4. Moving south along the bay, the beach narrows dramatically, transitioning to an irregular, rough and rocky shore in front of the subject property.

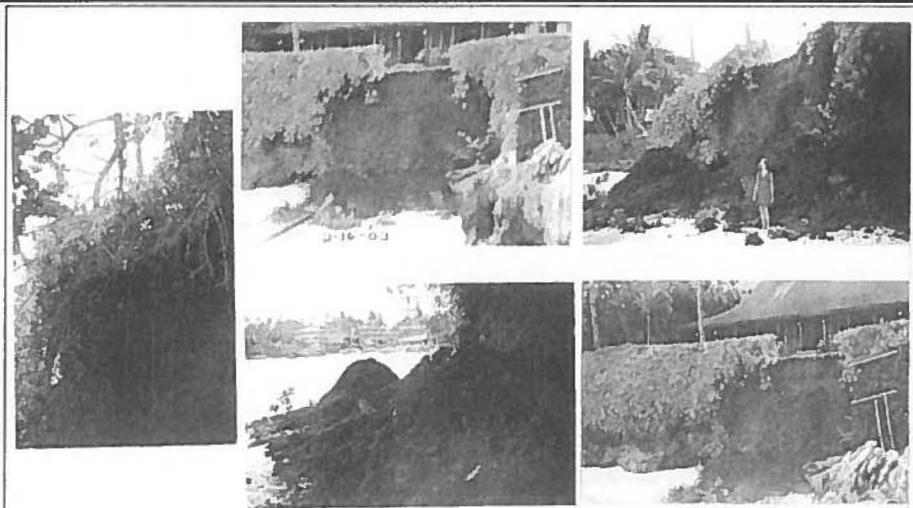
Figure A-5  
Site Photographs  
Hester Residence

Collapse of Shoreline Bluff at Subject Property, February, 2003

These pictures depict the collapse of the shoreline bluff at the subject property in February 2003.

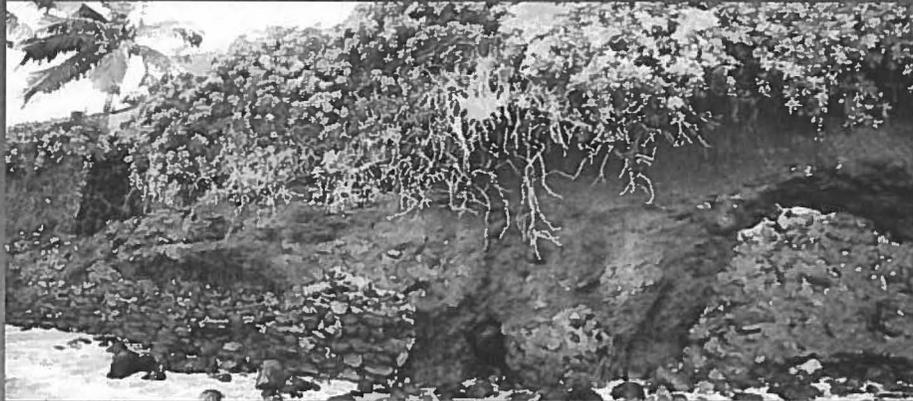
It has been determined by the project's coastal engineer that the seasonal erosion and bank destabilization in the bay is caused by a continuous bedrock layer of volcanic clay and cinder that is susceptible to erosion.

The bank is not made up of a stable solid rock formation resistant to erosion.

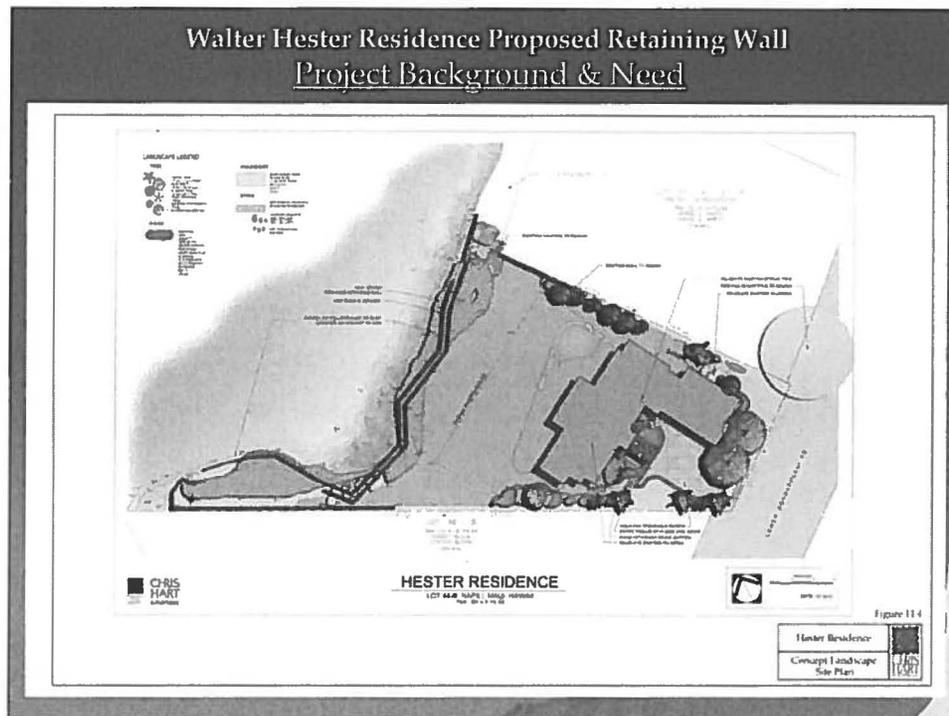
In this site plan you can see the outline of the original residence, and the site of the new residence, about 50 feet mauka.

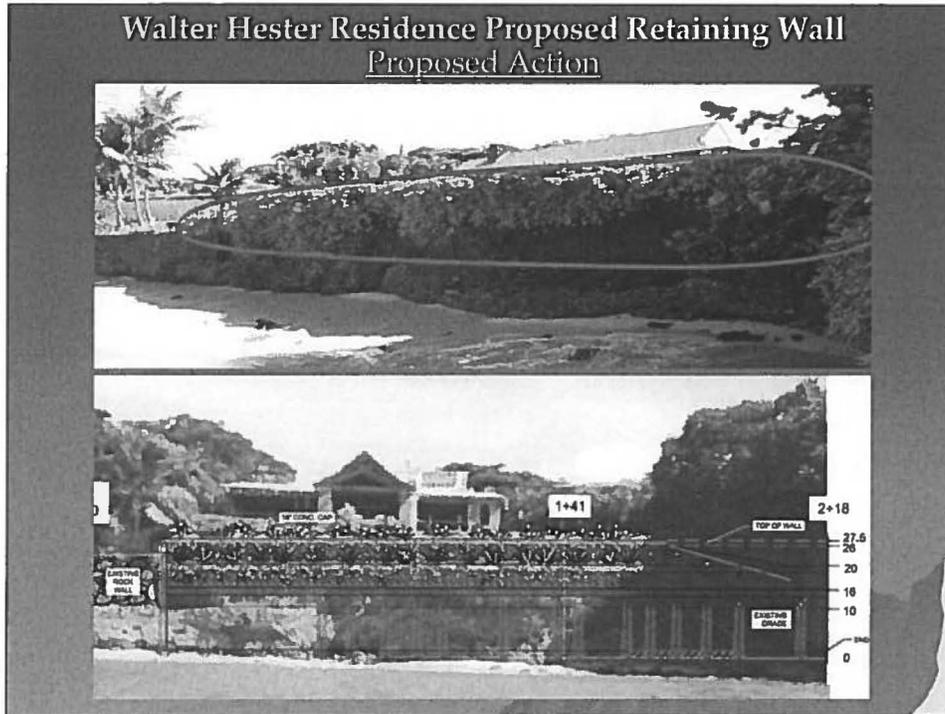
The Applicant proposes to construct a 10 foot high structurally engineered terraced slope retaining wall, sited on the rock within the bluff, at a base elevation of about 15 feet.

The purpose of the project is to enhance public safety and create a long-term solution that will stabilize the bank to prevent future erosion and undermining.

The proposed retaining wall will require a negligible amount of excavation and backfill and will be confined to the area above the beach and *mauka* of the certified shoreline.

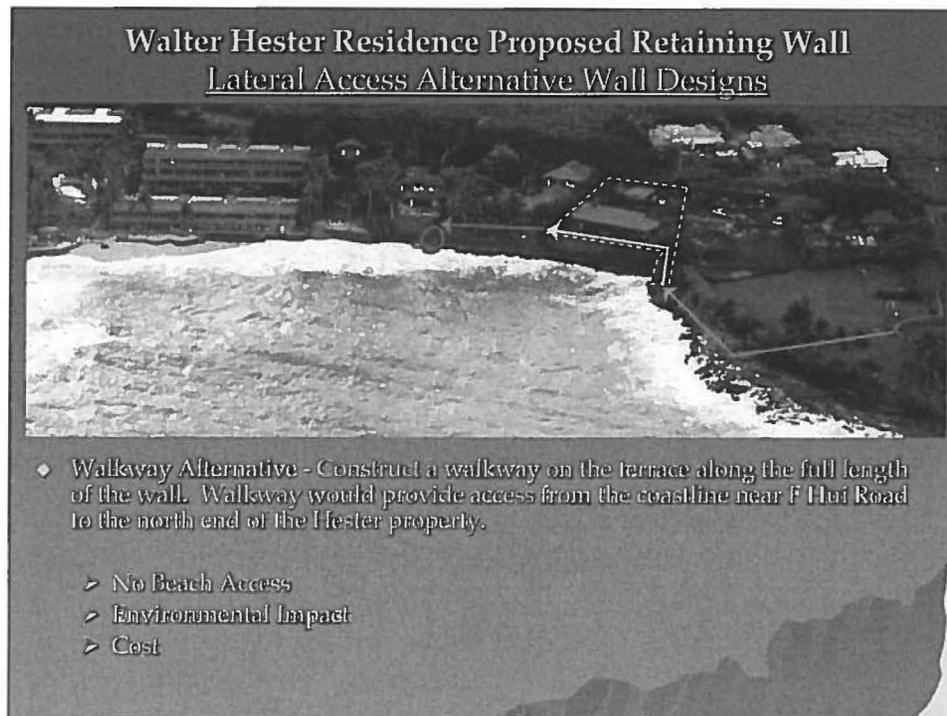
The first is the Walkway Alternative which would involve constructing a walkway on the terrace along the full length of the wall, as shown with the YELLOW arrow. The public would walk from F Hui Road to the coastline, and along the rocky coastline (as show with the GREEN arrow) to the south end of the Hester property where the walkway would start. The Walkway would provide access from the south end of the Hester property to the north end of the Hester property.

- That this alternative would not provide access to the beach. The walkway would end at the north end of the Hester property where there is no access to the beach. And as a reminder, there is no beach access from anywhere on the Hester property. To provide access to the beach the adjacent property owners to the north would also need to construct a walkway along their existing walls to the existing beach stairway, as shown with the RED arrow.

- The second important consideration is the potential environmental impact caused by construction of the walkway. The sea grape tree at the south corner of the Hester property would need to be removed to accommodate pedestrian movement along the wall terrace which would allow for erosion of the upper cliff and impact near-shore waters. \*\*\*\*\*NEED TO CONFIRM WITH PAUL WEBER\*\*\*\*\*

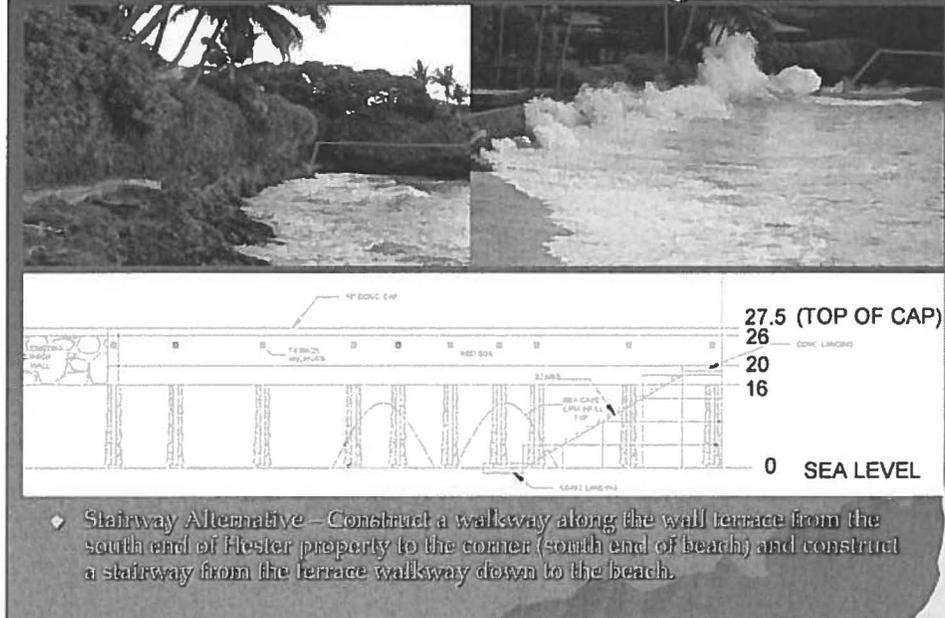
The second access alternative is the stairway alternative which would involve constructing a walkway along the wall terrace from the south end of the Hester property to the corner at the south end of the beach, then constructing a stairway from the terrace walkway down to the beach.

The beach access stairs would begin at a concrete landing on the top at about the position of the sea grape trees, at an elevation of 20 feet.

An angled bench would be carved out of the soil and rock on the standard 7 by 11 slope.

Dura-bloc would form protective retaining on both sides the stairwell.

A concrete landing would be constructed at beach level and the stairs would penetrate the cave nearest the south end of the beach.

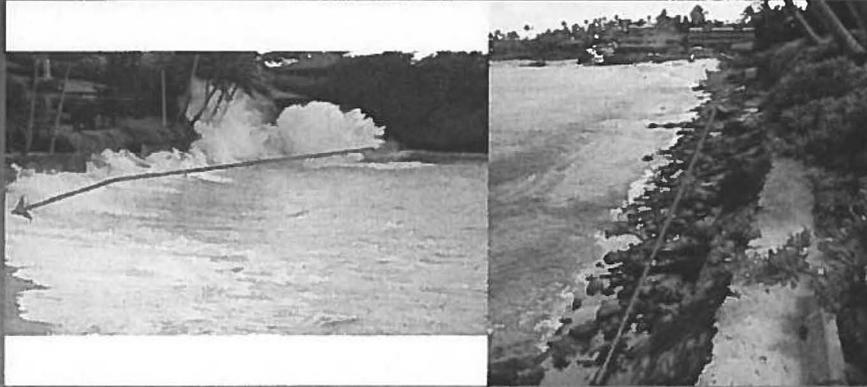
- First, safety and liability. The bottom portion of the stairway would frequently be under water or subject to dangerous wave action (as depicted in the picture on the left). Encouraging the public to access the shoreline at this location would create a public safety hazard. The stairway would create an attractive nuisance and serious liability issue for the property owner.
- Secondly, environmental impact. During construction of the stairway to the beach, erosion of the cliff and subsequent impacts to near-shore water would be unavoidable.
- And finally, cost. Again, construction of the walkway and stairs would approximately double the cost of the wall.

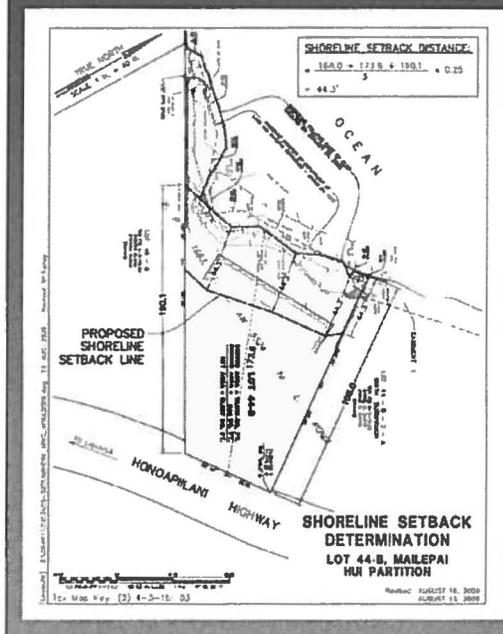
- ◆ Shoreline Survey Certified by D.L.N.R May 18, 2009
- ◆ Annual Erosion Hazard Rate (AEHR) does not apply
- ◆ Average Lot Depth (ALD) used to calculate shoreline setback
- ◆ Shoreline Setback = 44.3 feet

The shoreline survey was certified by the Department of Land and Natural Resources on May 18, 2009. The map indicates that the shoreline follows the base of a rocky cliff that runs along the *makai* boundary of the subject property.

The subject parcel is fronted by a high cliff, and the shoreline is to be fixed by an "artificial structure" therefore the Annual Erosion Hazard Rate (AEHR) method of calculating the Shoreline Setback therefore does not apply to the subject property.

Using the Average Lot Depth (ALD) method, the proposed shoreline setback for the parcel is **44.3 feet**

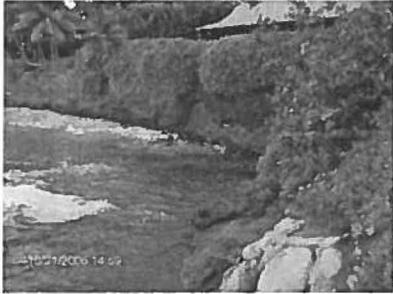
1. Sea Cliff Fronting Subject Property (Looking North East)

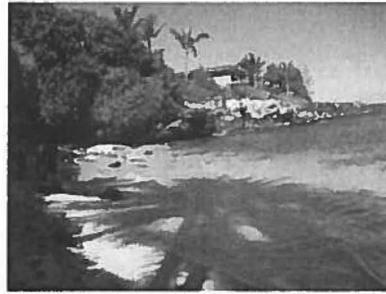
2. South End of Konoval Bay Fronting Subject Property (Looking South)

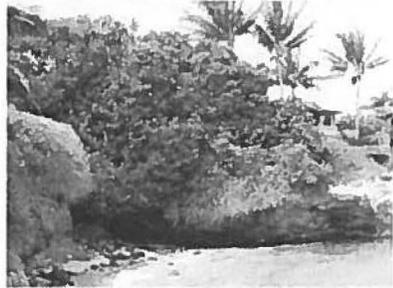
3. South End of Konoval Bay Fronting Subject Property (Close View) (Looking South)

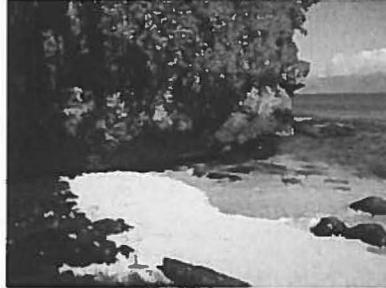
4. Sea Cliff Fronting Southern Most Portion of Subject Property (Looking South West)

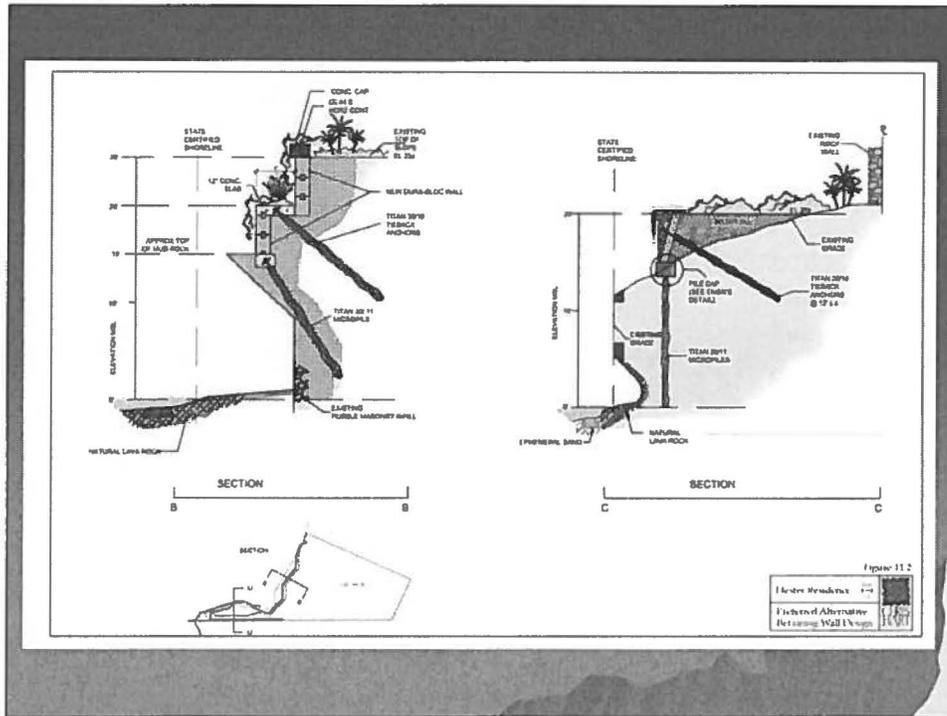
Section B depicts the proposed retaining wall design at a mid point along the property, where erosional caves have formed.

And Section C depicts the proposed retaining wall design along the southern end of the property, where the cliff face extends toward the point.

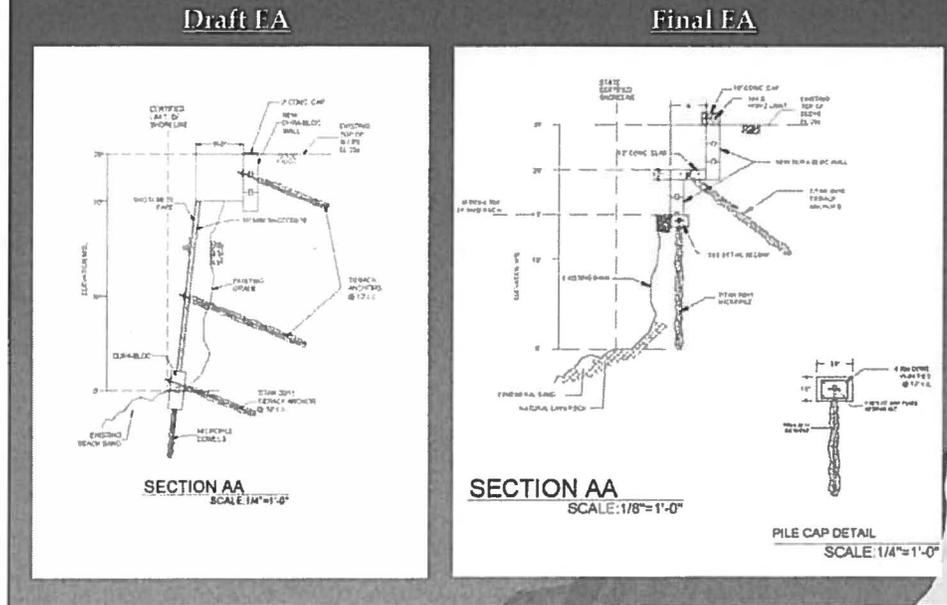
Here are the engineering drawings for the previously proposed wall and the revised retaining wall.

Again, the Draft EA wall design was a 25 foot high wall spanning the full height of the bank, while the revised design currently proposed is a 10 foot high retaining wall at the top of the bank.

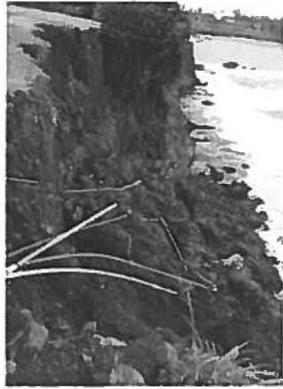
View of slope failure from above looking south

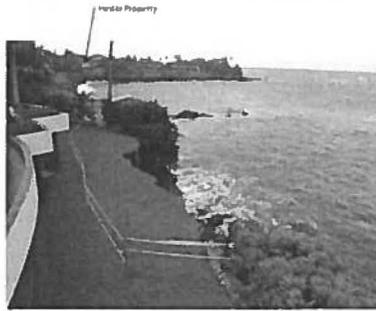
View from slope showing top of failed slope

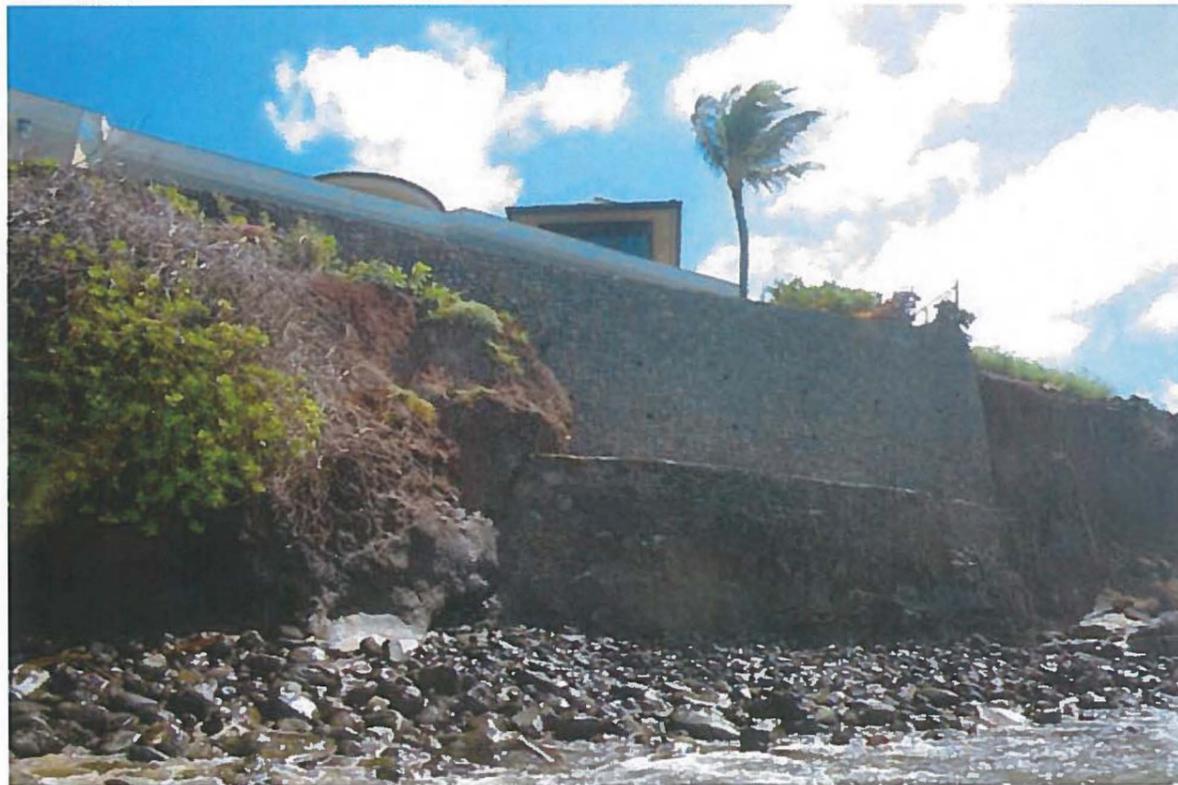
2. Completed wall and adjacent shoreline area, October 18, 2009

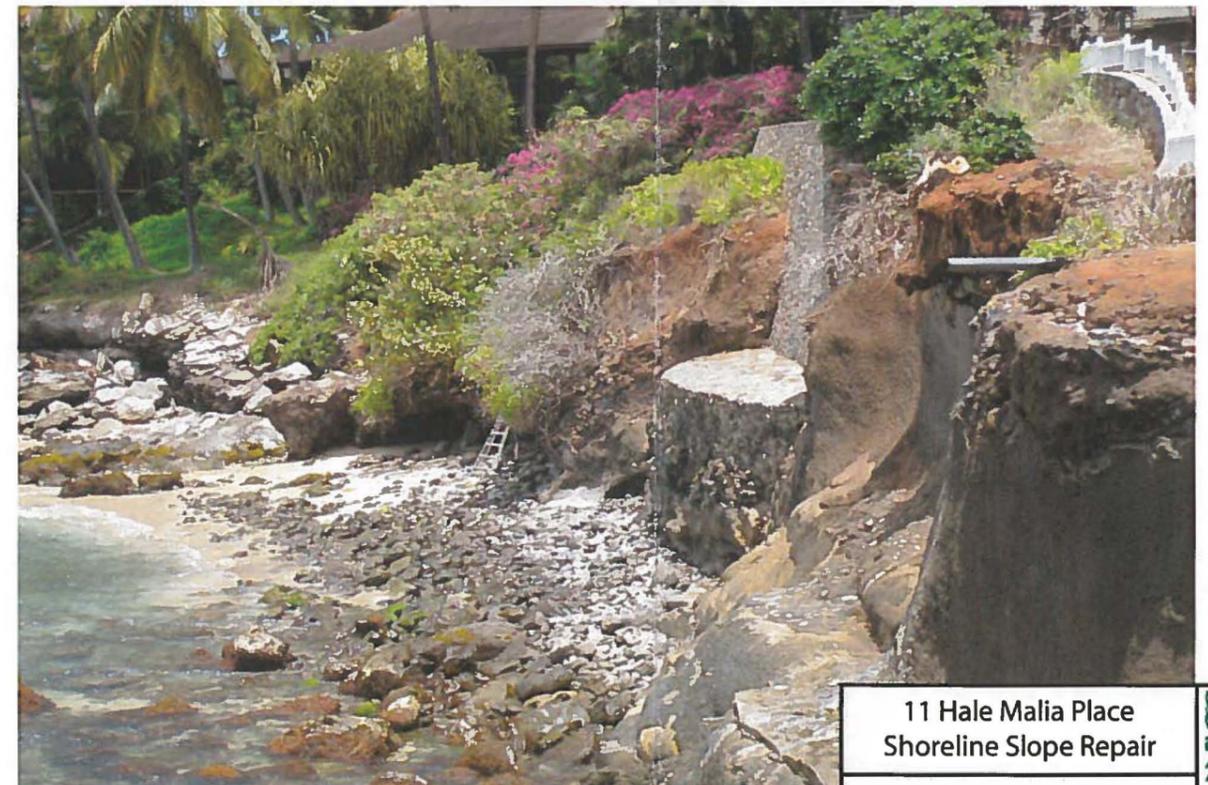
4. View of shoreline area and wall, facing north from Kahana Sunset property, April 29, 2010
