Historic Structures Report

OLD LAHAINA COURTHOUSE

December 16, 1996

**Spencer Mason Architects
1050 Smith Street
Honolulu, Hawaii 96817
(808) 536-3636**

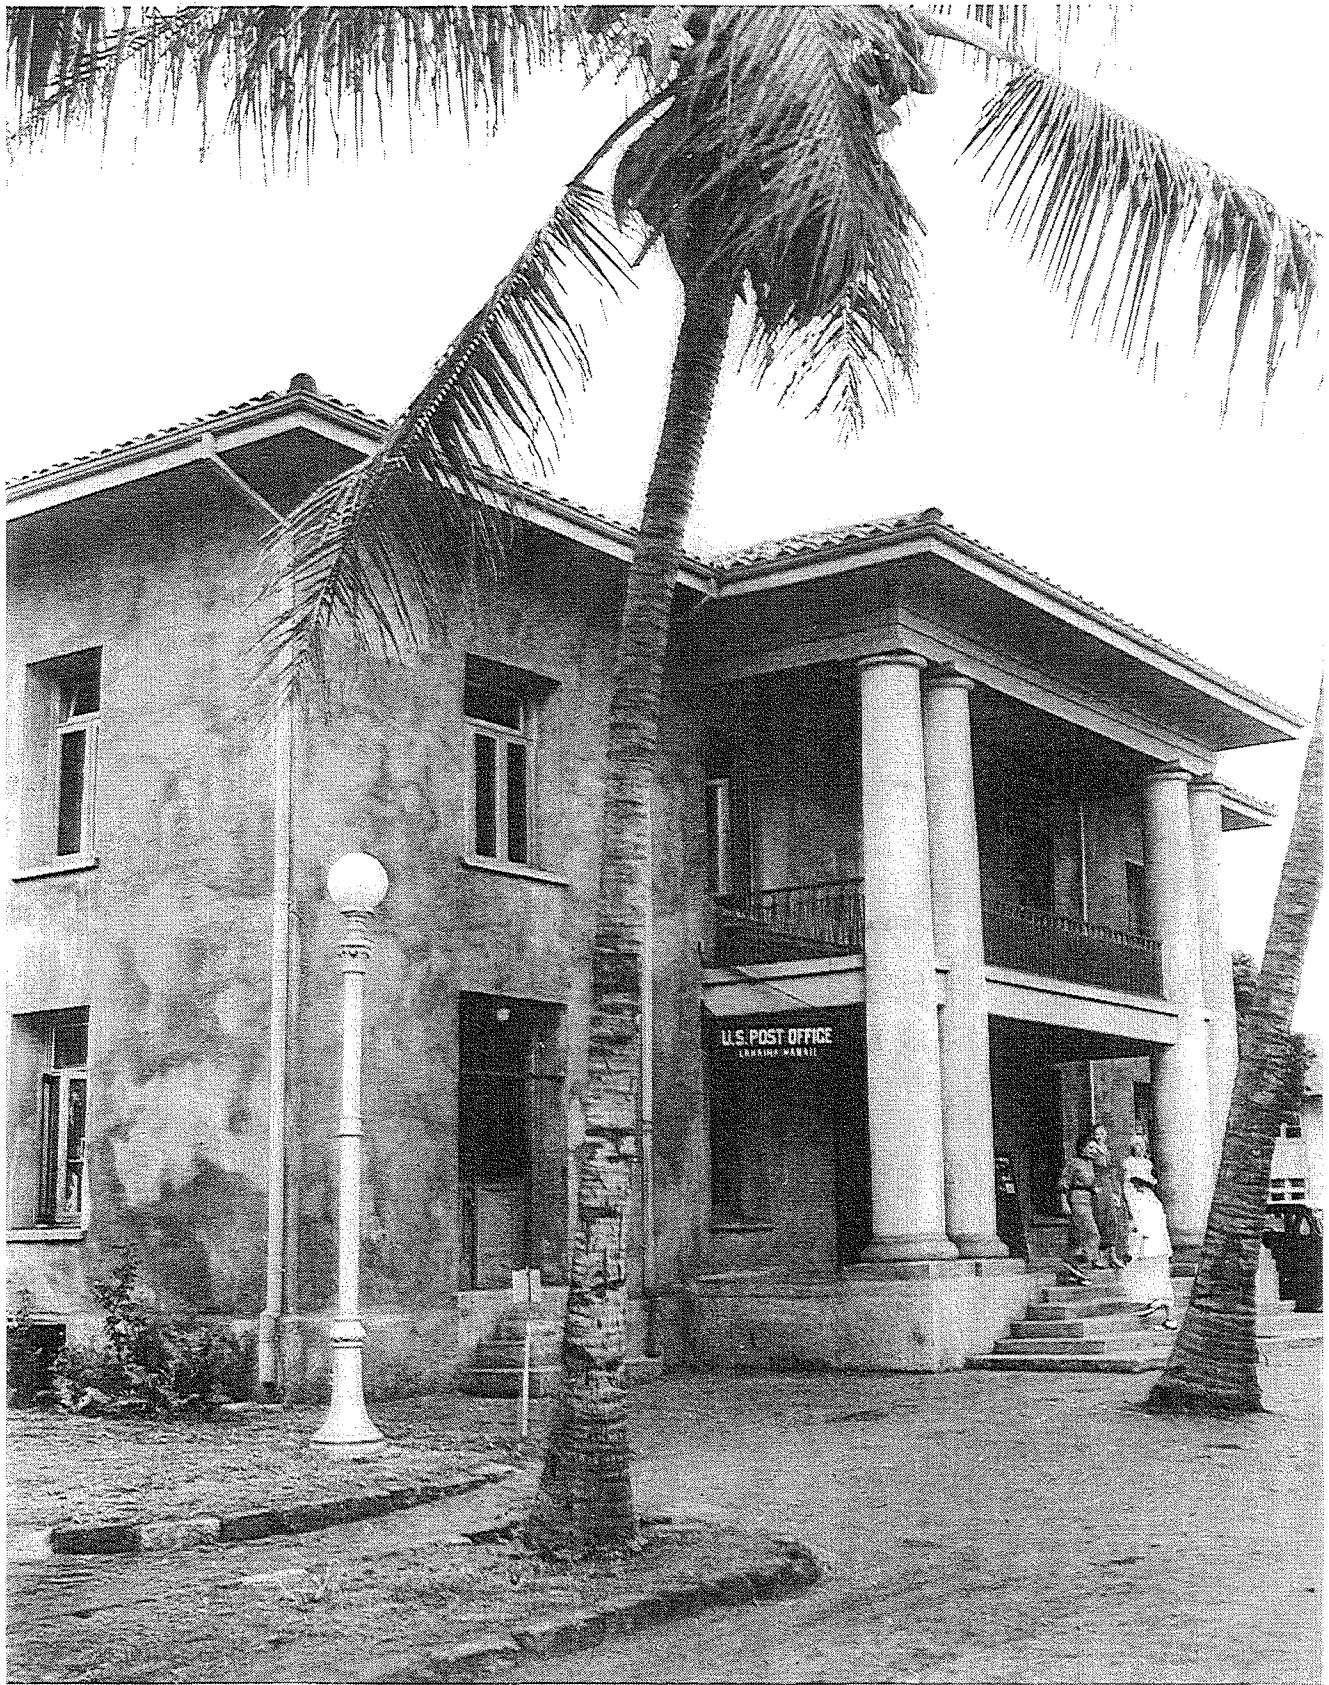
Figure 3. Lahaina Courthouse exterior, 1935 - (State Archives)

The original roofing was a clay mission tile (figure 3). The existing roof covering is asphalt shingles. The asphalt shingle roofing appears to be in fair condition. The existing sheathing, truss system and ceiling framing appear to be in very good condition. Structural analysis and recommendations are detailed in Appendix "A". All the eave vents have broken screens which have allowed birds to enter the attic (figure 10).

- 1. The mission tile roofing should be reinstalled, using a good quality clay tile matching the profile that can be seen in the historic photographs. This type of roofing is durable and although it needs regular maintenance is not a high-maintenance roof. It should be installed with stainless steel nails and stainless steel hold downs.*
- 2. The roof structure should be tied to the exterior walls at the wall plate. (See structural report, Appendix "A")*
- 3. All screens at the attic vents should be replaced with stainless steel mesh.*

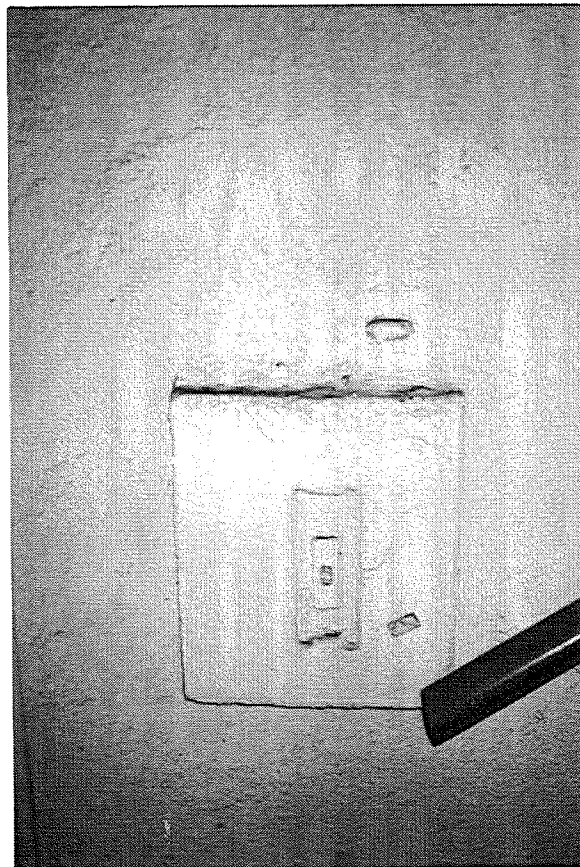
Figure 19. Latch strike at basement entrance

Bifold steel gates were installed in the opening of Door 17 and at each of the basement entrances. The steel gates ran in a track at the head, which still exists in each location. Above the track at door 17 the metal bars in the transom above still exist. The original latch strike for the folding gate still exists at the Kaanapali entrance to the basement (figure 19).

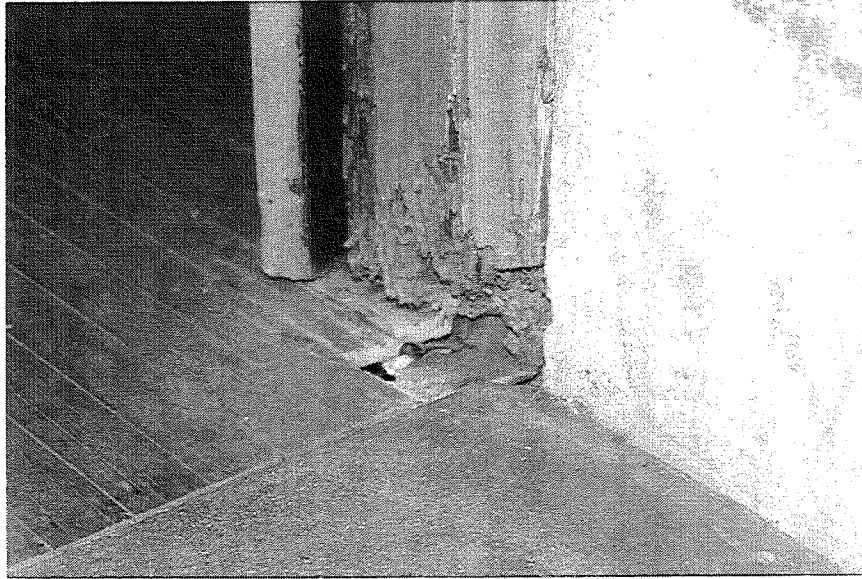
Figure 22. Termite damaged jambs

The floor in the first floor lobby has areas of termite damage, most of which are adjacent to the wall below the stair. In this central hall area approximately 5 - 10% of the floor boards are damaged. There is also termite damage in the floor at the jambs of the exterior door no. 12 (figure 21). On the second floor the floor in the Hall has been repaired with approximately 10 metal plates covering damaged areas of flooring. The floor at the threshold to door 4 is damaged. In the room with W13 the floor is worn and also has metal plate repairs.

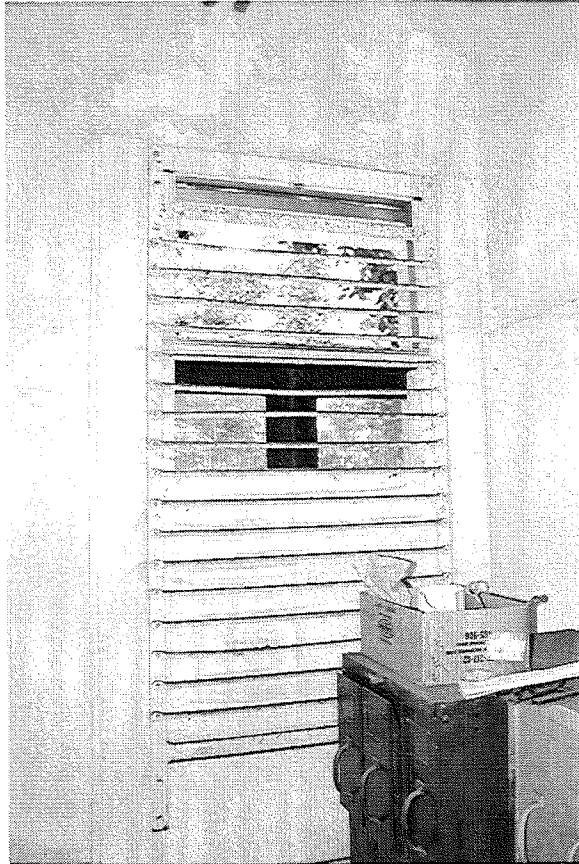
Figure 29. Bars on window in later holding cell

Miscellaneous Window Elements - There are metal security bars on the inside of windows 14 & 15 at the former jail (figure 29).

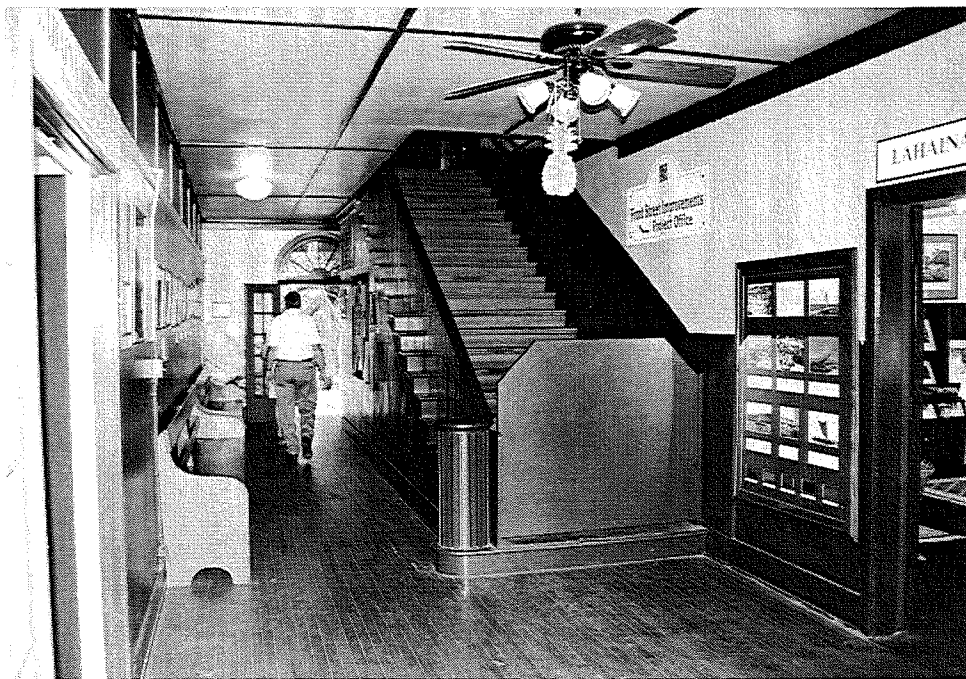
Figure 30. Stair at first floor

The stair from the first to second floor is a straight flight (figure 30). The molded handrail is supported on closely spaced square balusters and terminates in a circular newel at the lowest step. A round wood hand rail is fixed to the wall. The guardrail at the second floor hall is 2'-6 1/4" high and the handrail is 2'-8 1/2" high above the line of the nosings.

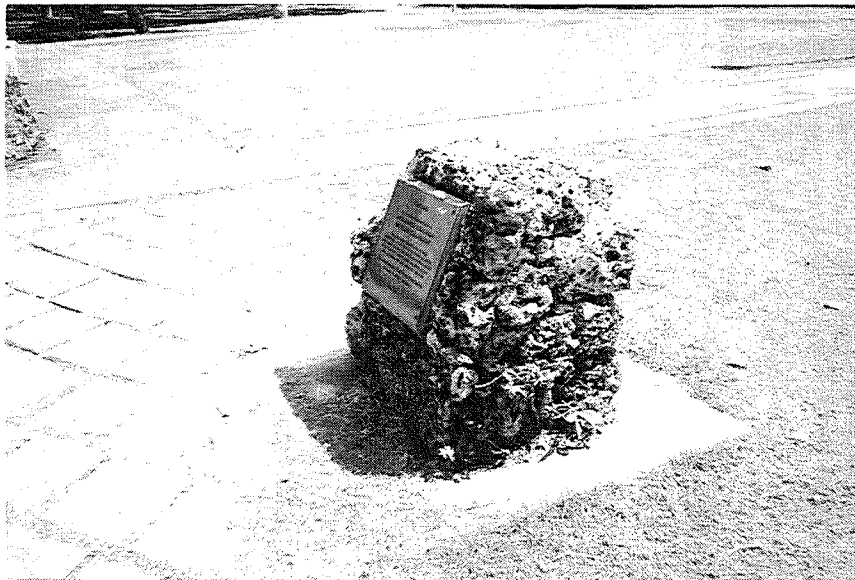
Figure 32. Marker on stone pedestal

There is a bronze plaque commemorating the National Historic Landmark status for Lahaina, dated 1964, on a pedestal made of coral stone (figure 32). The coral blocks, some of which have been sawcut to better fit together, sit on a concrete slab roughly 45" by 54" in size. One stone is missing from the upper left corner of the pedestal.
